PROJECT PROFILE

BICKFORD RESIDENCE

Rain Garden

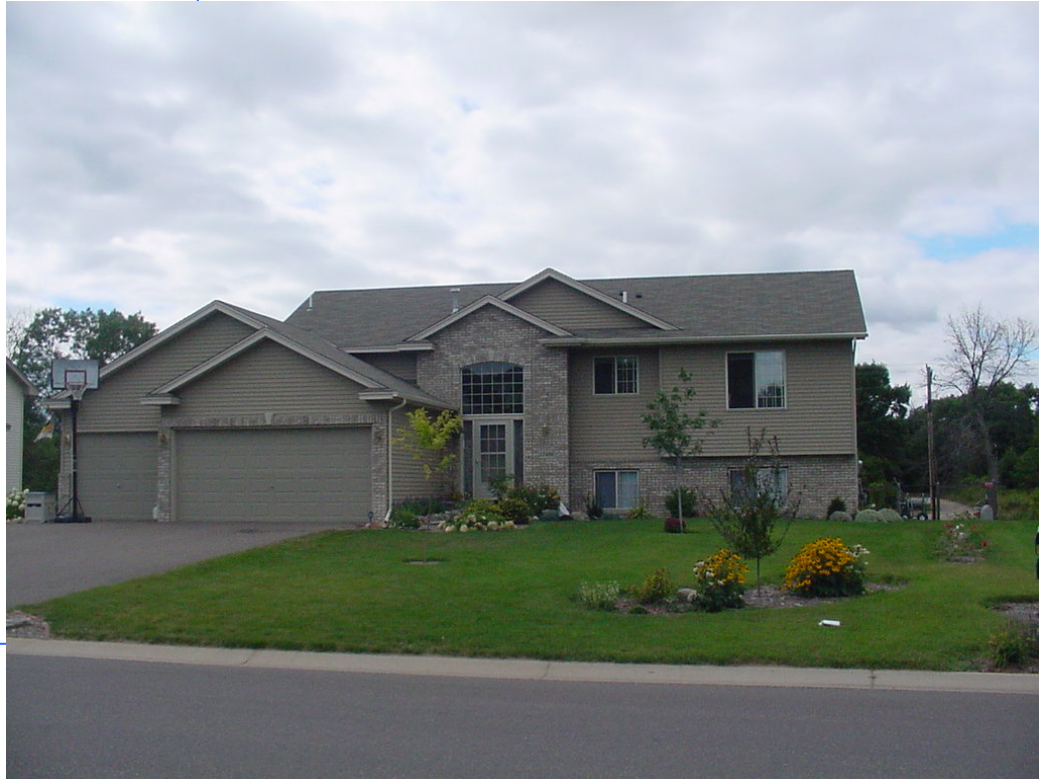
September 2003

The existing landscape featured many non-native plants that required a lot of maintenance and had high water requirements. At the same time, the landscape was set up so that the water falling on the roof was quickly dispersed onto the lawn where it flowed to the street. Ultimately, the stormwater ended up in the Rum and Mississippi Rivers.

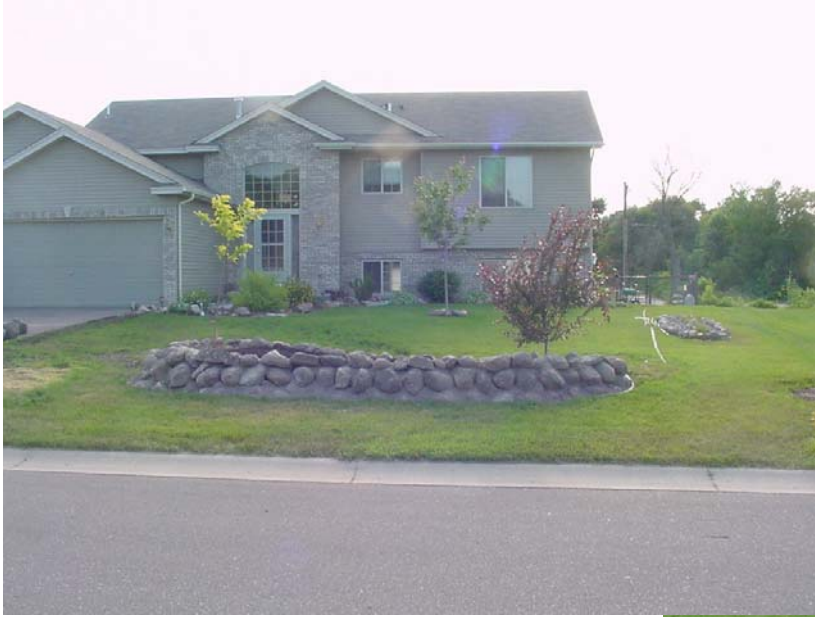
March 2004

After Rain Garden Installation

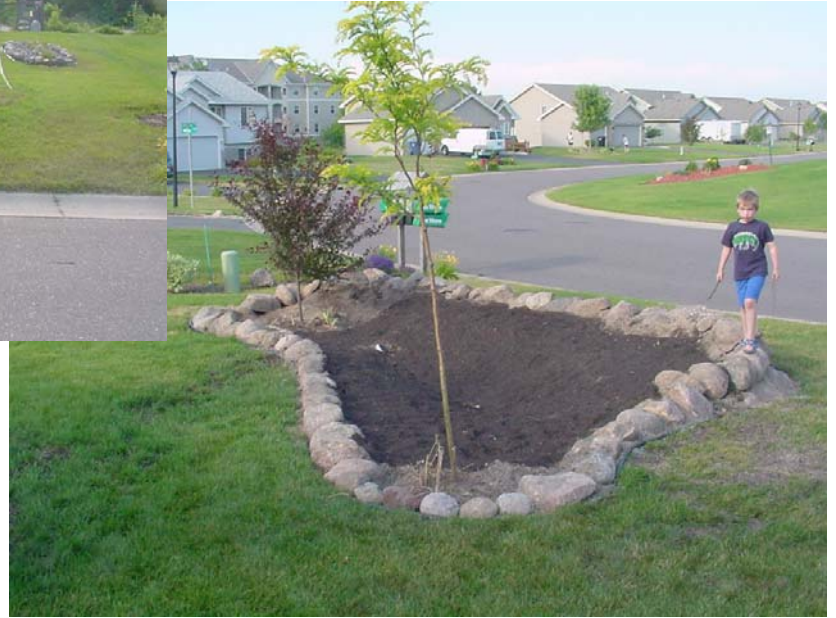
The rain garden is designed to capture and treat stormwater falling on the roof and reduce supplemental watering.

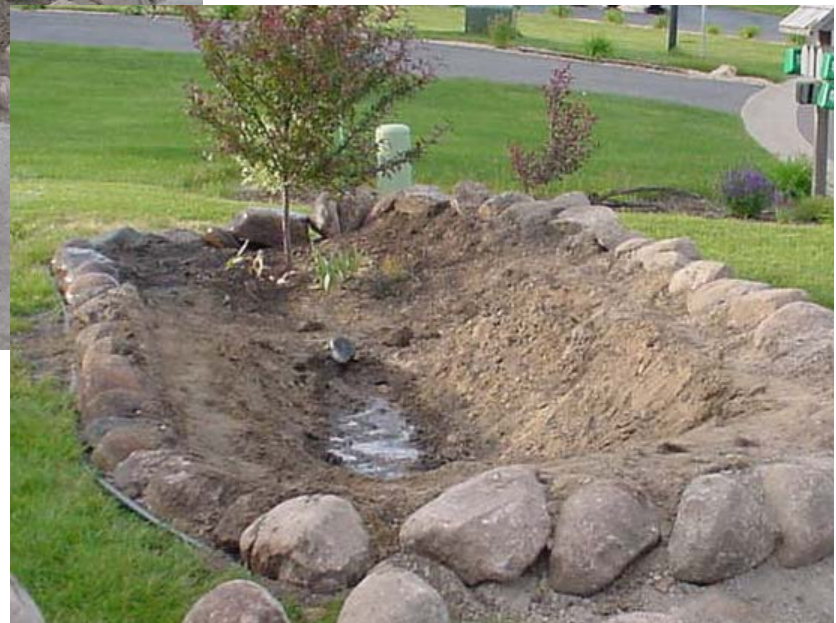
March 2004

Water falling on the roof is directed by drain tile into the new rain garden. The rain garden can treat up to 102 ft³ of storm water.
