# CHAMBERLAIN

## Pre-Buffer Conditions

ANOKA  
CONSERVATION  
DISTRICT

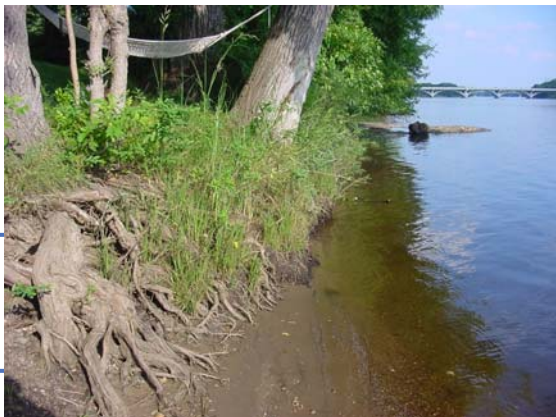
Actively eroding banks are threatening the trees near the shore (August 2003)

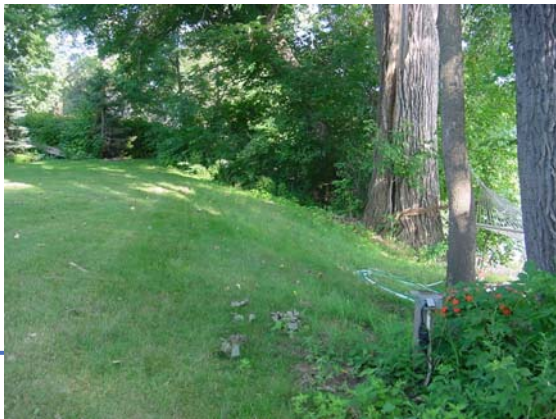
Turf reaching down to the water's edge is easily undermined due to the small root systems of lawns (August 2003)

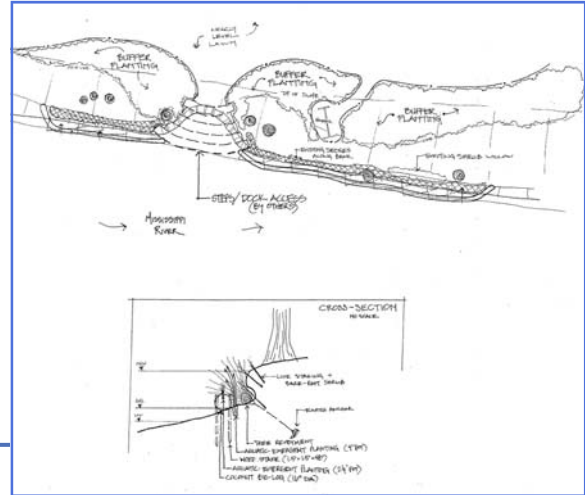
The restoration plan is pictured above. The project is located on Levee Ave on the east bank of the Mississippi. Please respect private property!

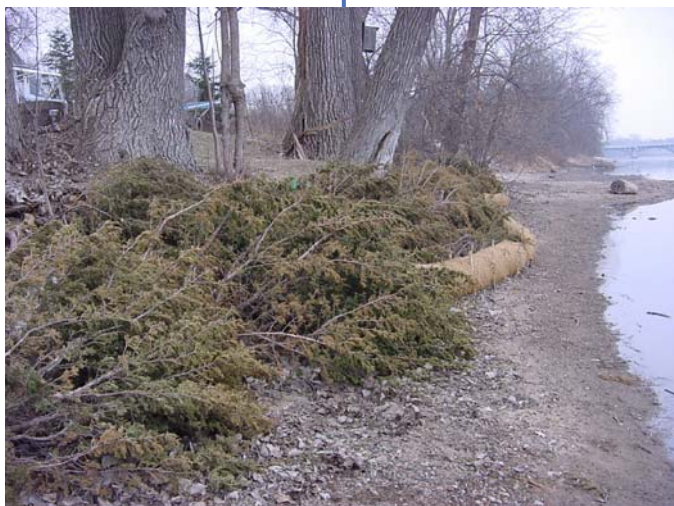
◀ March 2004

8' - 12' cedar trees were harvested with permission from a local property. Branches from one side of the tree were removed so the tree trunks fit tight up against the bank. Enough cedars were harvested to allow for a 2' overlap of the trees. Biologs were placed in front of the cedar trees to allow for increased sediment accumulation along the bank.

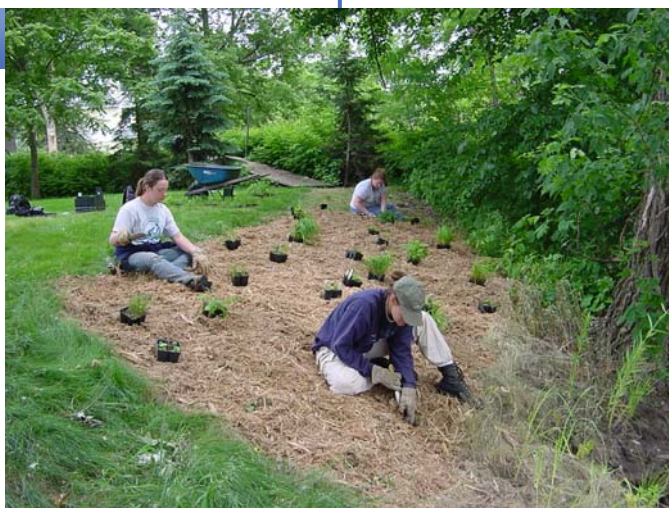
March 2004 ▶

The upland buffer was widened to improve the root structure within the bank and increase plant diversity. Aquatic vegetation was planted into the cedar revetments to help reduce water velocity along the bank after the cedars decay.

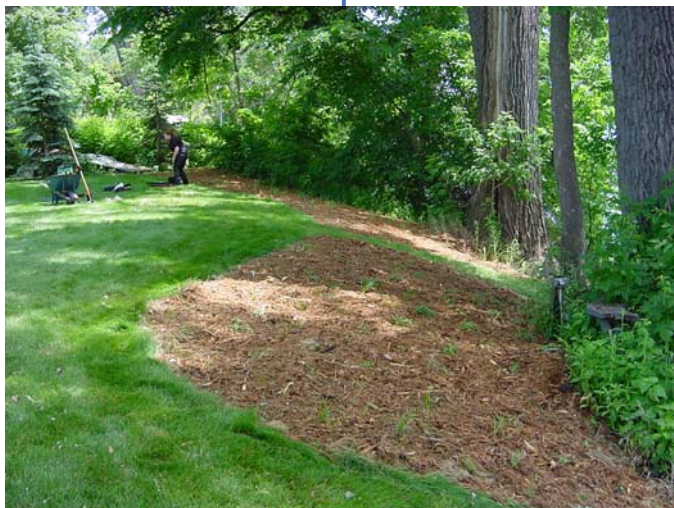
◀ June 2004

The completed planting will take several years to mature. During that time regular maintenance will be done to remove any problem species that appear such as buckthorn or thistle.
