# COLBERG STREAMBANK STABILIZATION

CENTERVILLE, MN

Streambank Stabilization

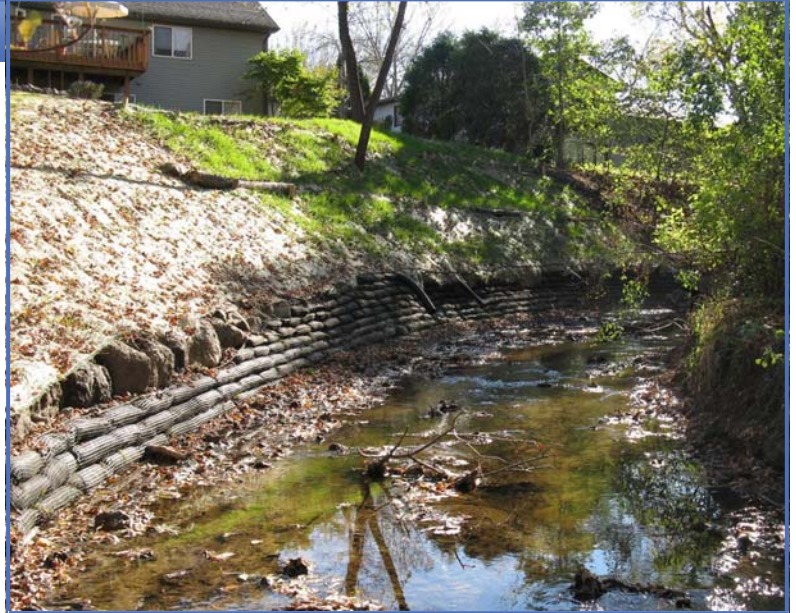
Completed project early in the fall of 2011.

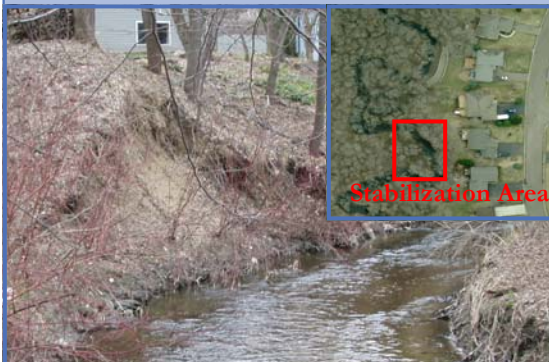
Pre-stabilization conditions consisted of an actively eroding streambank and sparse understory vegetation, which provided no benefits to water quality or wildlife habitat.

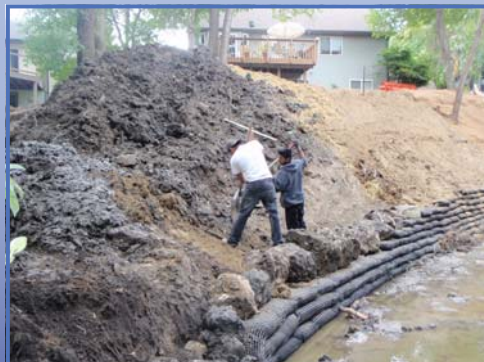
The Envirolok vegetated wall system was installed at the toe of the streambank, and the rest of the bank was graded to achieve acceptable slopes (3:1 to 2:1).

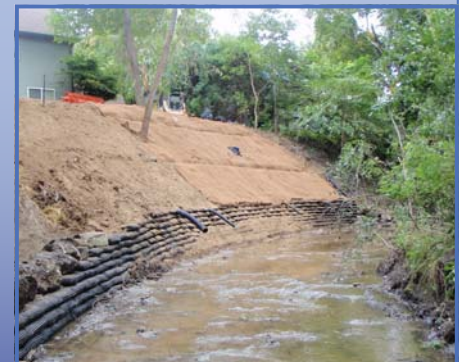
Erosion control fabric was placed prior to seeding and planting with deep-rooted native vegetation to provide additional bank stability.
