# 2010 CROOKED LAKE RAIN GARDENS

## Project Summary

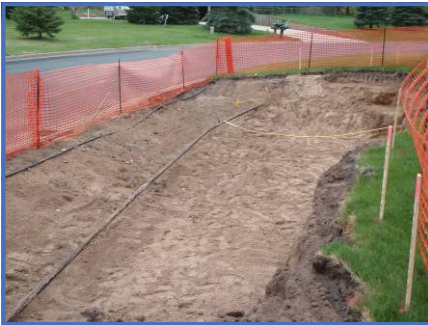
Site preparation and soil excavation to achieve desired side slopes and 1 ft. maximum ponding depth.

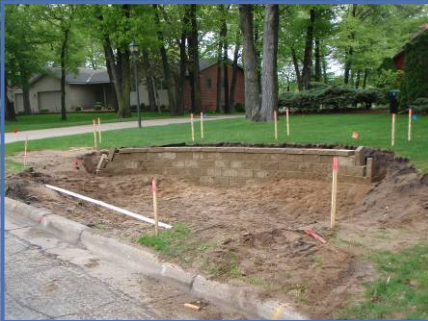
Retaining wall construction, as well as soil amendment with rain garden soils to promote treatment and infiltration.

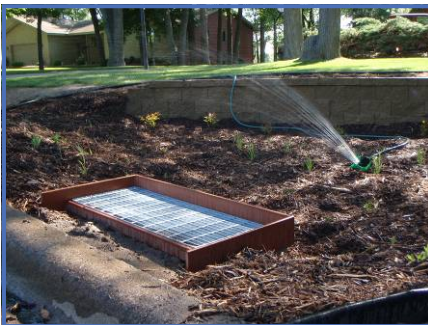
Placement and installation of pretreatment chamber and plant positioning.

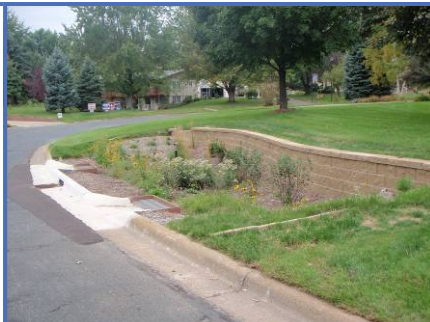
Curb-cut construction to accept offsite runoff from curb and gutter system.

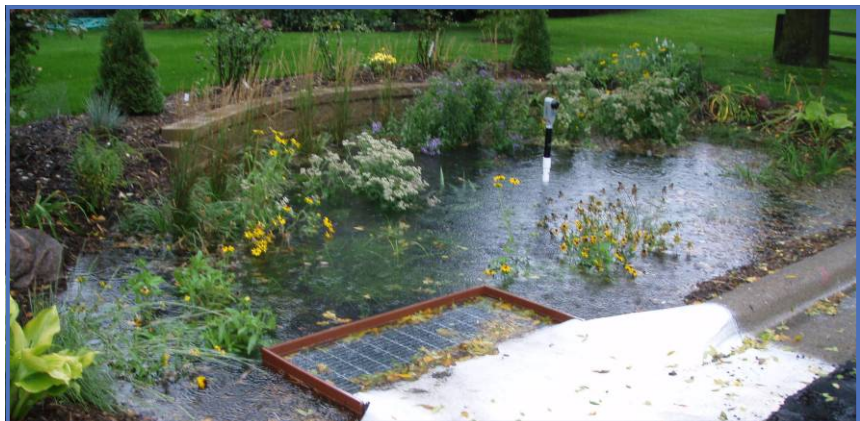
Fully functioning curb-cut rain garden. Note the properly installed pretreatment chamber that filters incoming runoff and also prevents debris and sediment from entering or exiting the rain garden when filled to capacity.

Post-project monitoring by ACD verified acceptable rain garden infiltration rates and proper pretreatment chamber function following storm events. Monitoring will continue during the 2011 growing season to ensure proper garden function and successful plant establishment.
