PROJECT PROFILE

EIDE RESIDENCE

Rain Garden

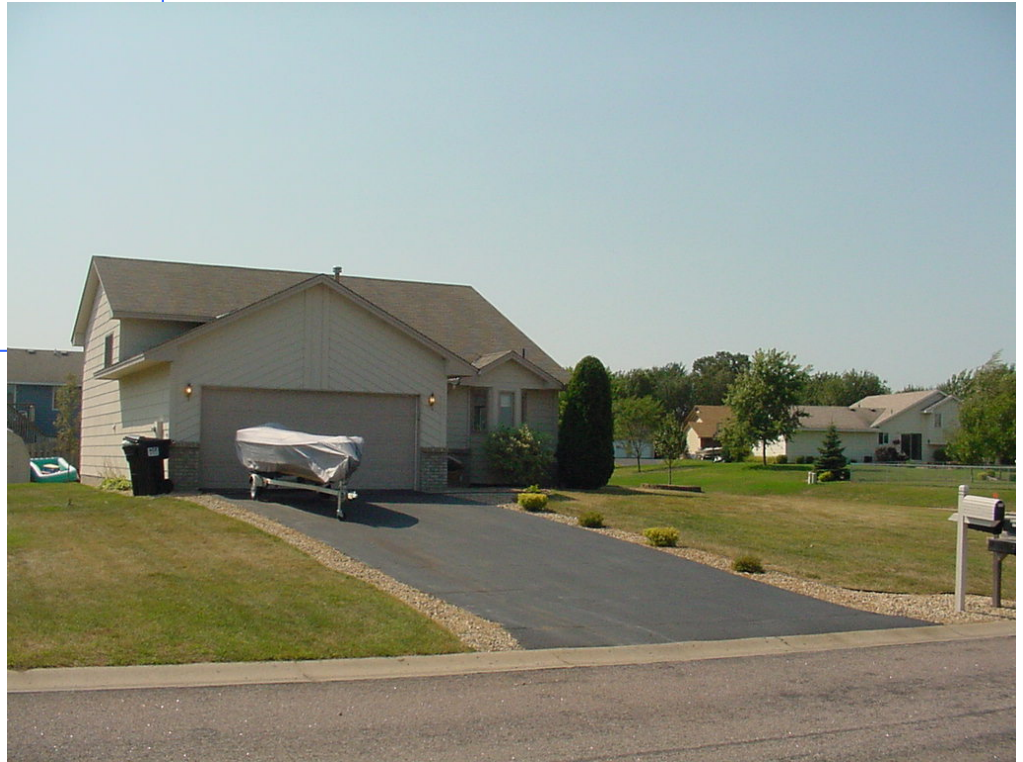
August 2003

Before the rain garden was installed, stormwater falling on the roof was discharged onto the lawn where it quickly flowed into the street and ultimately ended up in the Mississippi River.

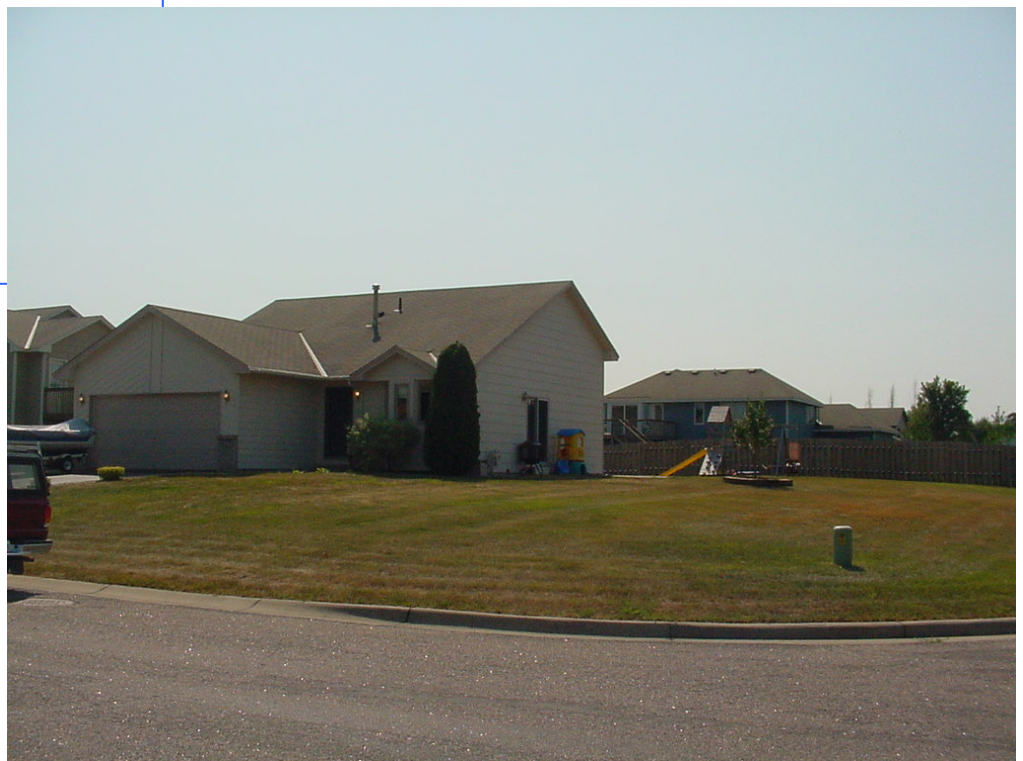
August 2003

The rain garden was designed to capture rainwater coming off of the roof. Value of labor provided by the homeowners was estimated at \$1,037.50. The project was authorized for up to \$1,442.15 in cost-share funds through the Met Council.

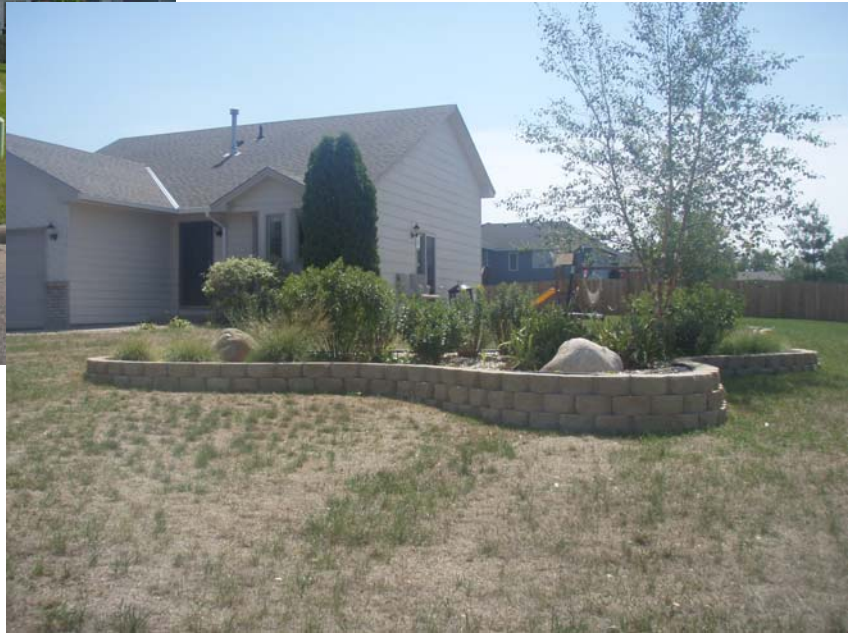
August 2007

Rain falling on the roof is directed by drain tile to the rain garden for treatment.

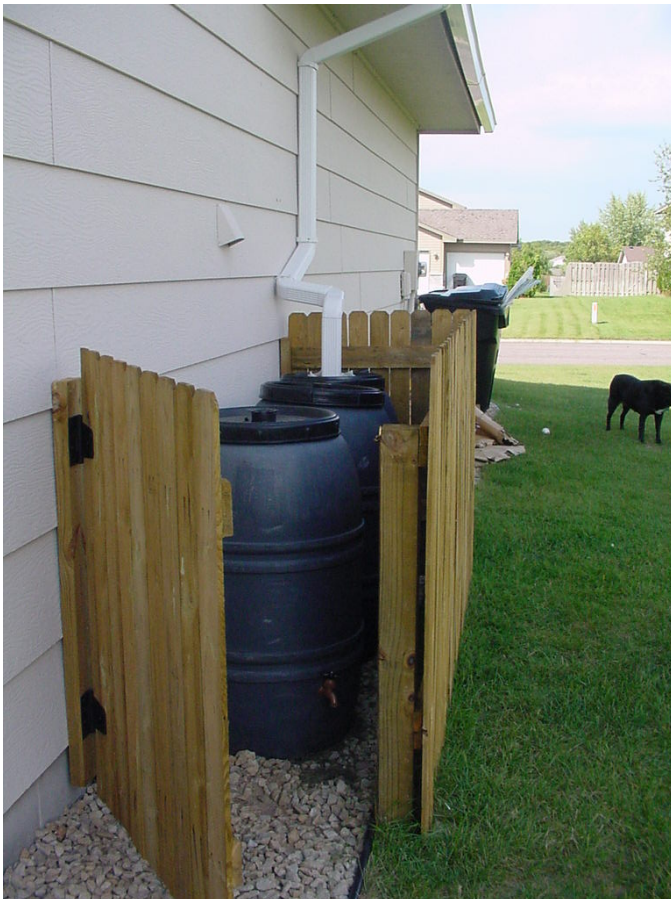
The rain gardens can treat up to 87 ft³, reducing pollution and nutrient input to the Mississippi River. Additional stormwater from the roof is collected in rain barrels for use in watering.
