PROJECT PROFILE

# HERRALA AND RUSIN

River Bank  
Stabilization

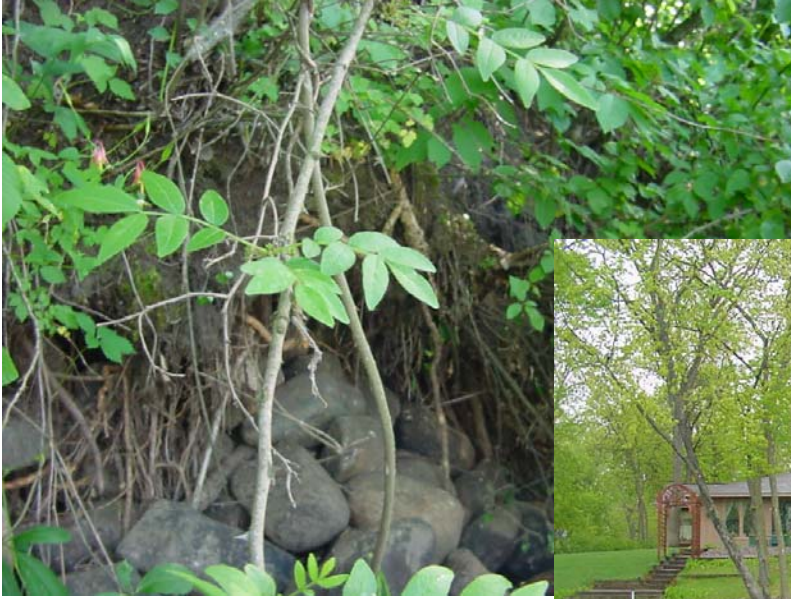
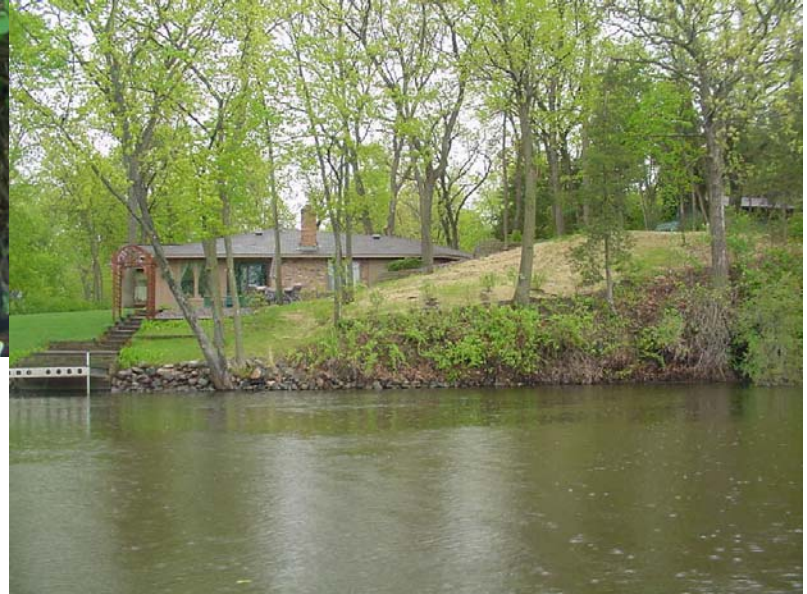
May 2006

This site had minor erosion and bank undercutting. Homeowners previously attempted to stabilize the shoreline with rock. The length of shoreline needing attention was approximately 158 ft.
