JOHNSON & MILLER SITE

Pre-Stabilization Conditions

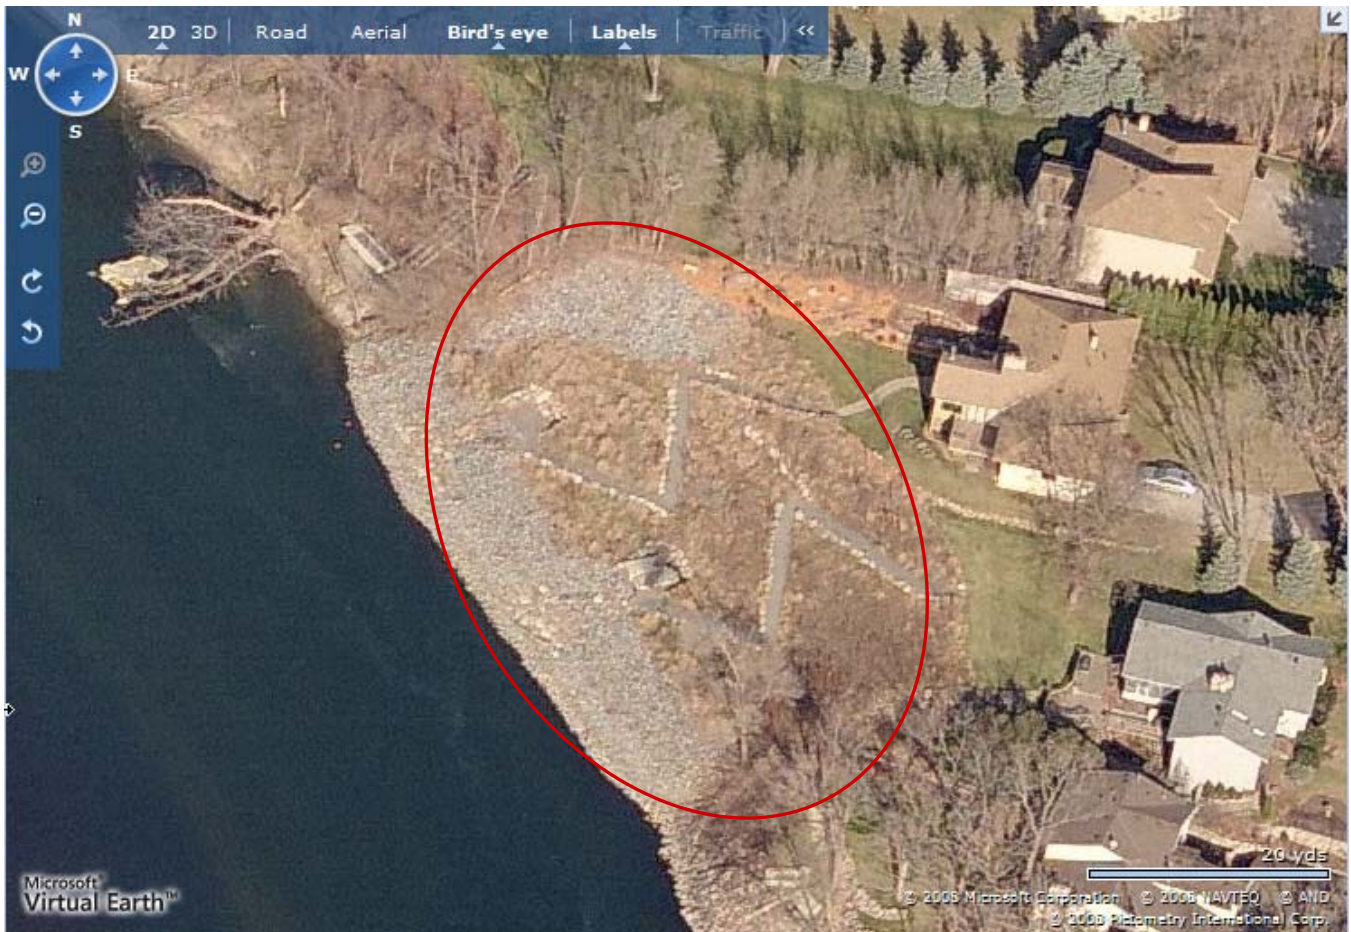
Before Installation

This site had recently suffered a bank failure resulting in very steep slopes. Following the failure, risk of erosion due to storm events and wave action on the Mississippi River was greatly increased.

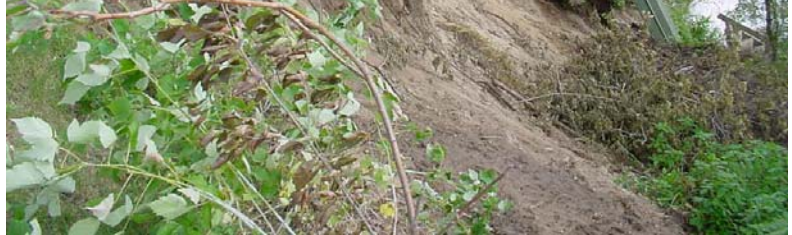
Installation

The slope was re-graded to reduce the slope angle and reduce the risk of future bank failure. Riprap was installed up to the 10-year flood elevation to reduce the risk of erosion due to river action.

After the site was re-graded to reduce the slope angle, riprap was installed from the base of the slope up to the 10-year flood elevation. The riprap provides protection against erosion caused by wave and current action of the Mississippi River.

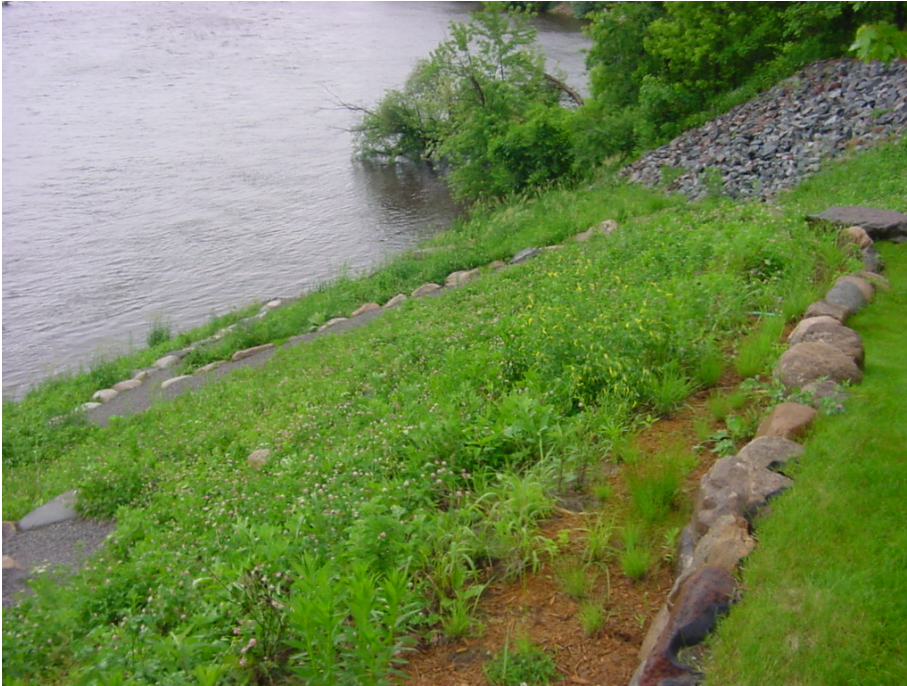
◀ June 2005

A variety of native shrubs, trees, grasses, and flowers were planted above the 10-year flood elevation following re-grading and installation of erosion control blankets. The use of diverse native plants increases wildlife habitat, increases bank stability by creating a dense root network, and is aesthetically appealing.
