LACH RESIDENCE

Rain Garden

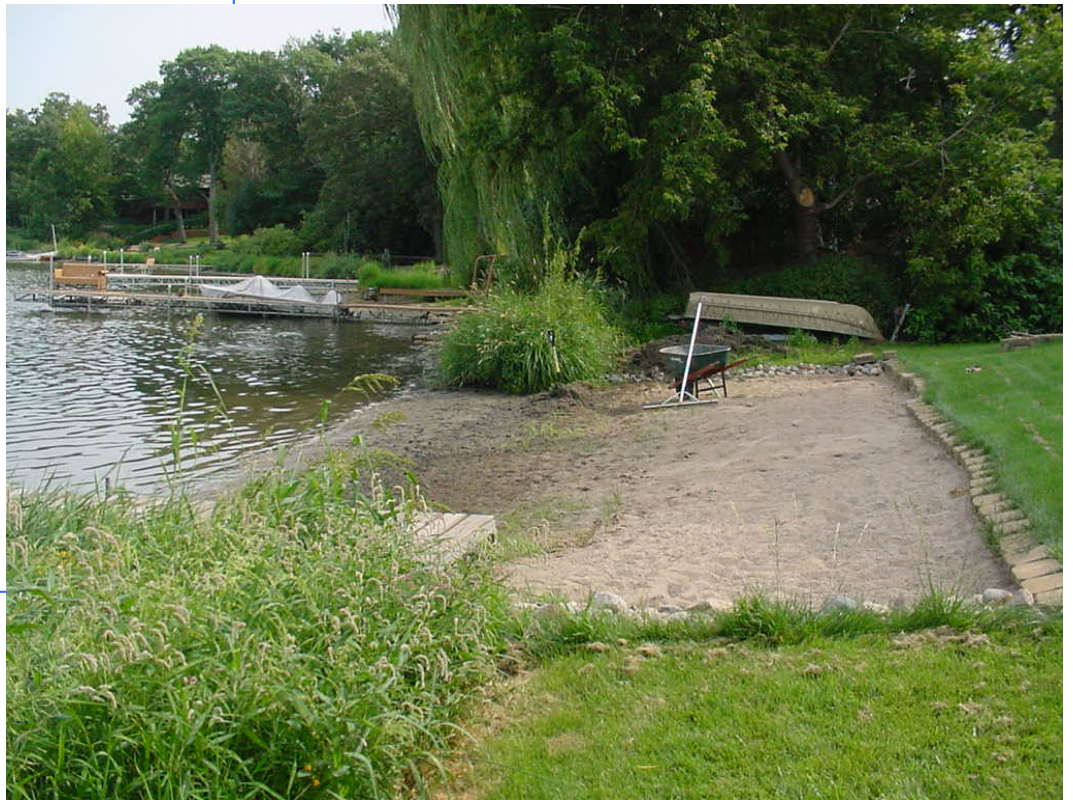
September 2003

Prior to rain garden installation, there was little buffer to help reduce runoff into Crooked Lake.

The limited buffer area that was present was dominated by invasive reed canary grass. A number of rain gardens were constructed at a total cost of \$8,961.51. The homeowners were reimbursed \$4,480.76 in cost share funds.

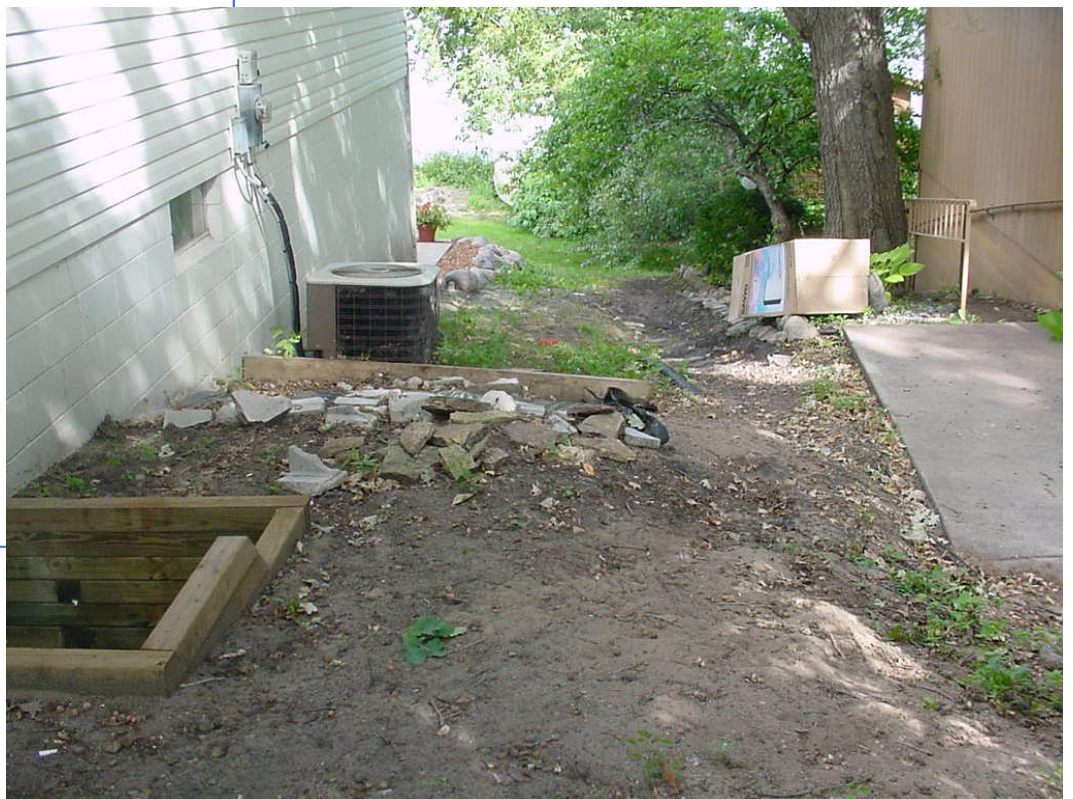
September 2003

Prior to rain garden installation and drainage improvements, runoff from the Lach's front yard and part of their neighbor's property all flowed through this narrow area. Water rapidly flowed along side the residence resulting in erosion problems and increased sediment input into Crooked Lake.

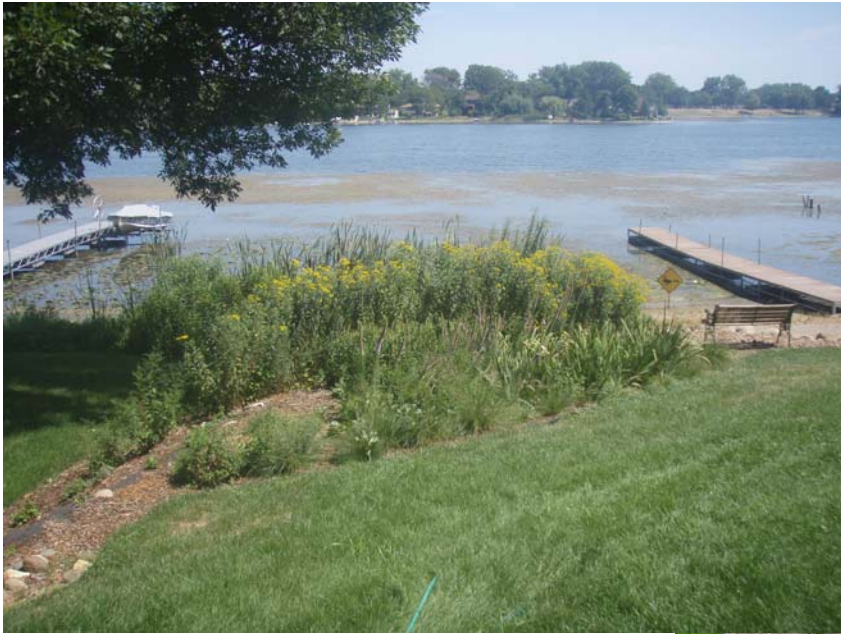
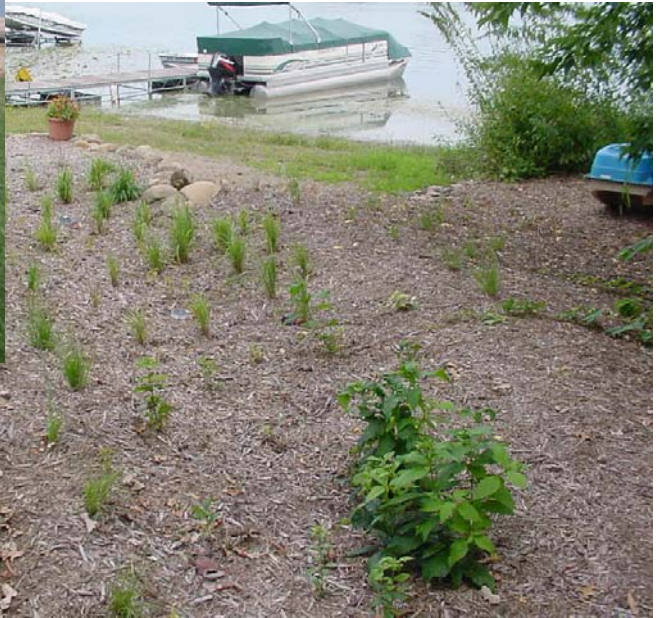
June 2004

504 native plants were planted in the Lach rain gardens increasing diversity and bank stability.

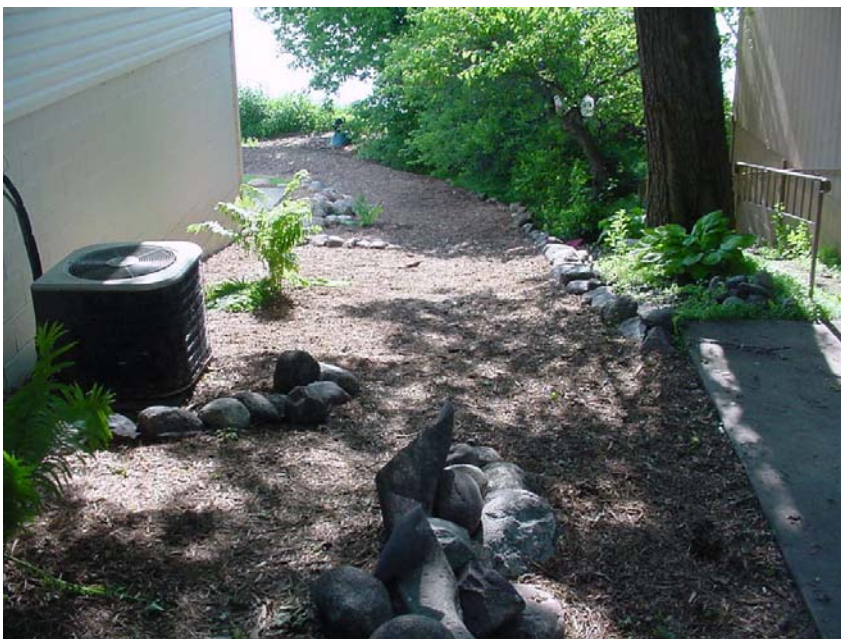
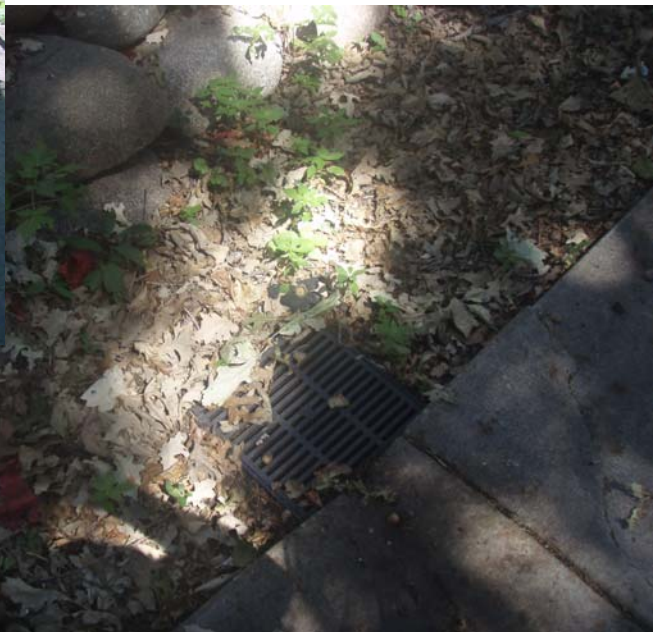
June 2004

Runoff is collected in a drainage basin where it is directed to a rain garden for treatment. Runoff is reduced leading to less erosion damage.
