LORD RESIDENCE

Rain Garden

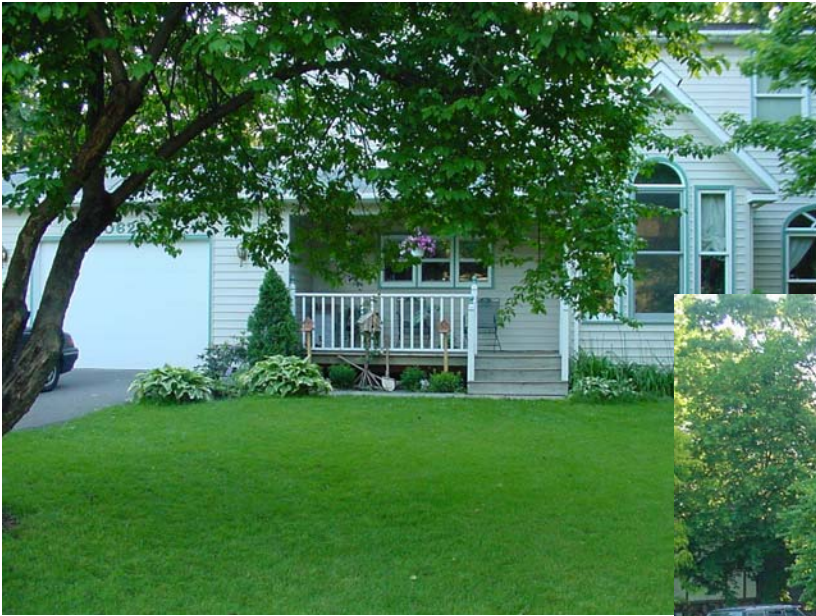
May 2003

Before Rain Garden Installation

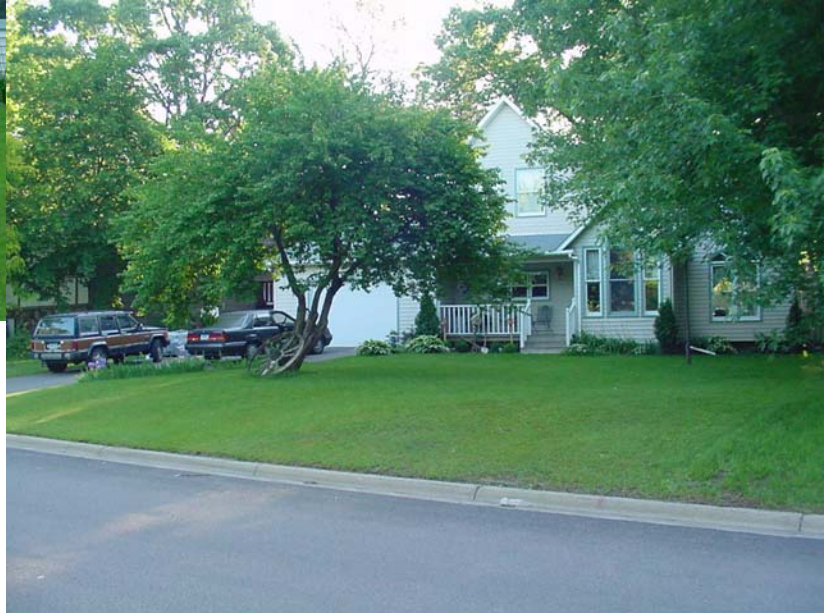
Rain falling on the roof is discharged into the street where it enters the storm sewer system.

Rain falling on the roof of the Lord residence was discharged into the street, eventually making its way to the Mississippi River via the storm sewer system. This excess runoff from impervious surfaces can cause:

- An increased risk of flooding and bank erosion
- An influx of sediments, nutrients and pollutants
- An increase in water temperatures.

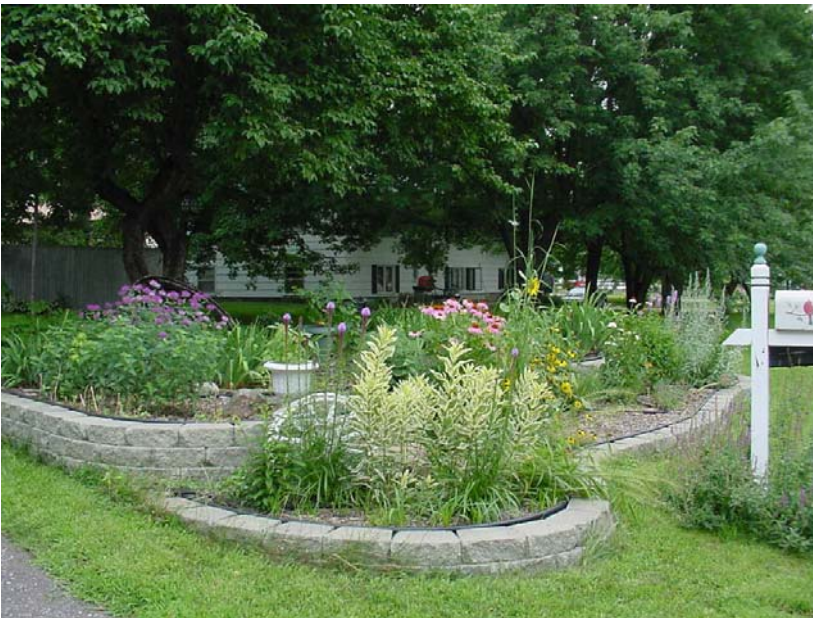
June 2005

After Rain Garden Installation

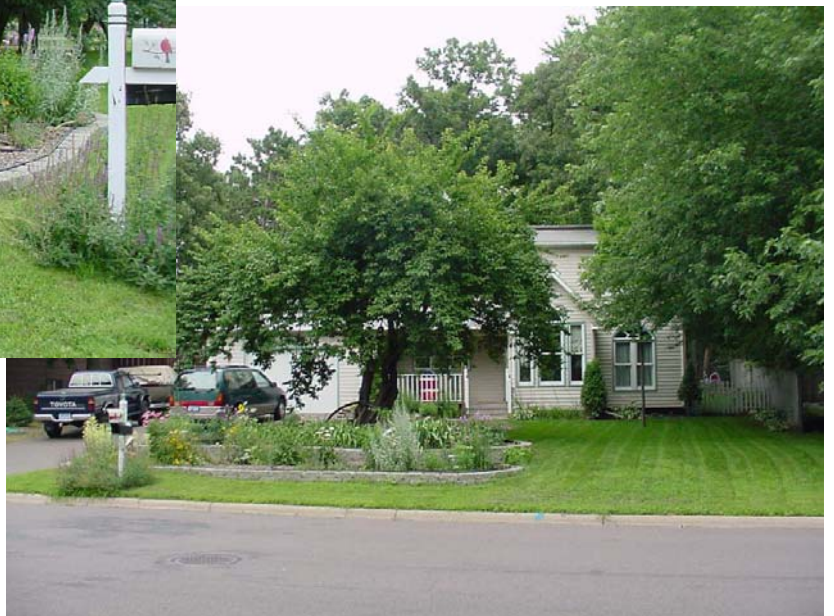
The rain gardens can treat up to 116 ft³, reducing pollution and nutrient input to the Mississippi River.

Water Treatment Capacity 116 ft³
