# PETRO STREAMBANK RESTORATION EAST BETHEL, MN

Streambank Restoration

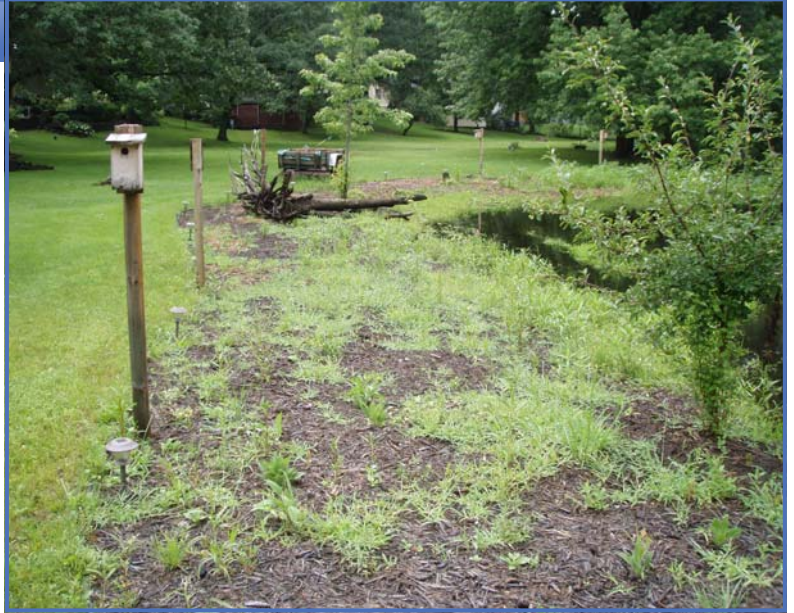
Completed project in the summer of 2011.

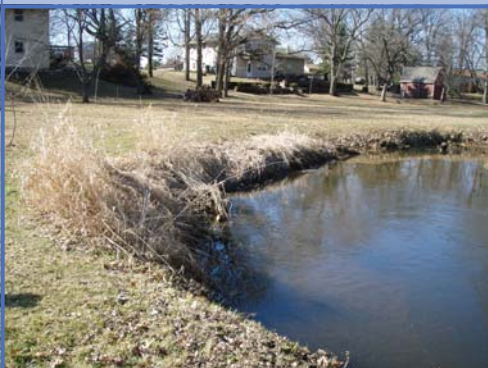
Pre-stabilization conditions consisted of a severely undercut streambank and no buffer, which provided no benefits to water quality or wildlife habitat.
