Martin Lake Rain Gardens

This project is a direct result of the 2011 Martin Lake Stormwater Assessment. That project identified opportunities to improve treatment of stormwater before it reached Martin Lake. Among the stormwater retrofits, several rain gardens ranked among the most cost effective.

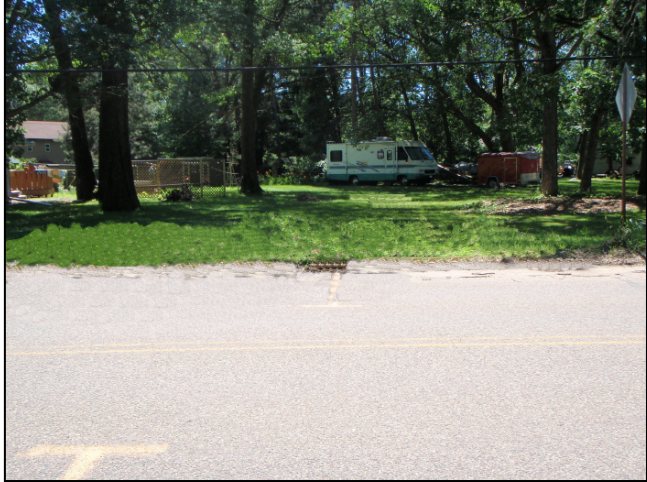
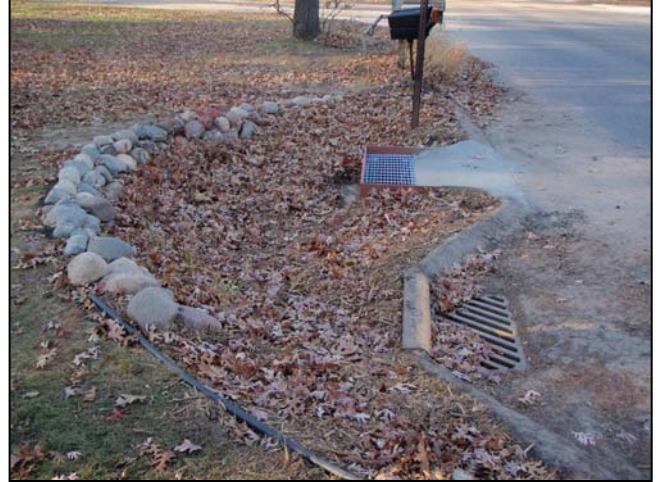
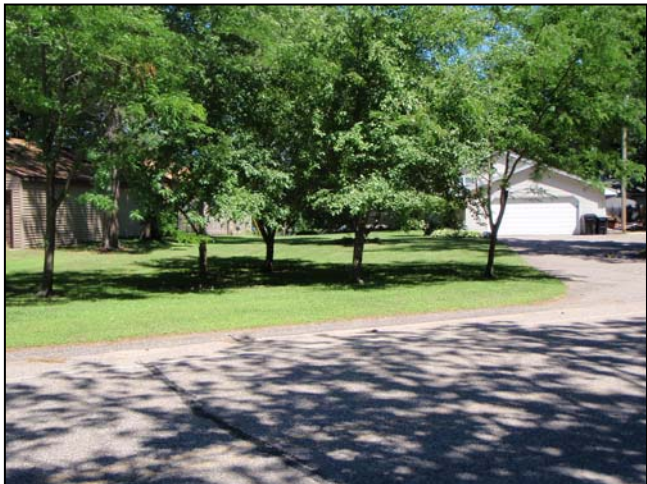
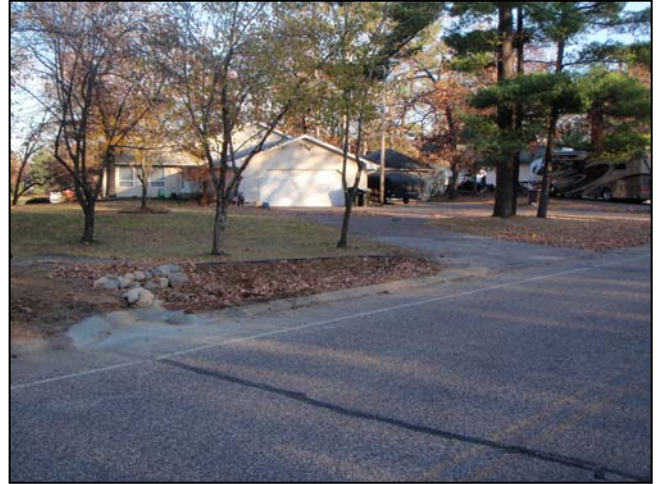
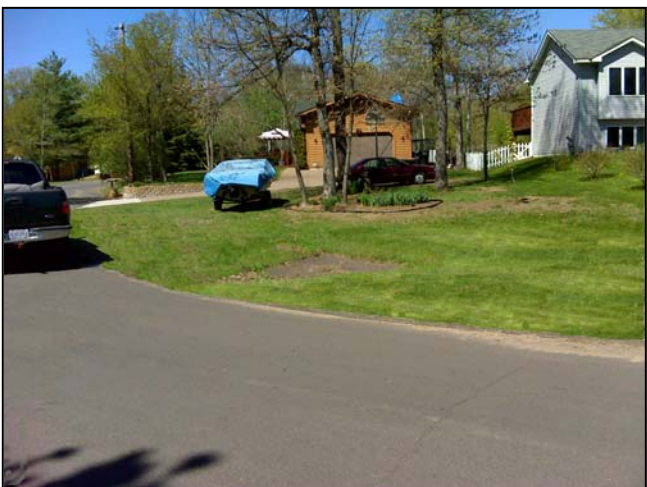
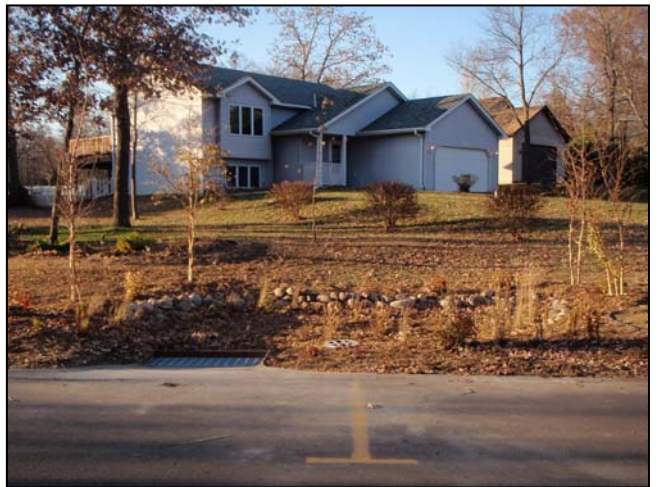
Before and after photos of the installed rain gardens. The “after” photos were taken in late fall. Flowers and other plants will be more apparent in the spring.

In fall 2011 three residential, curb-cut rain gardens were installed in the yards of willing homeowners. All of these rain gardens were located at the end of a long run of curb, and just up-gradient of a catch basin that would direct the water into the lake. A cut in the curb was created, directing the water into the excavated rain garden basin. In the rain garden, storm water soaks into the ground through the engineered soils. Standing water is present for no more than 48 hours after storms, and often much less. If the garden fills to the curb elevation during heavy rains, water will simply pass by the rain garden and go to the catch basin.
